June 5, 2013

**RE: *Gulfstream Towers Association
KEG File No. 13RS-1020
Professional Engineering Services – Reserve Study***

EXECUTIVE SUMMARY

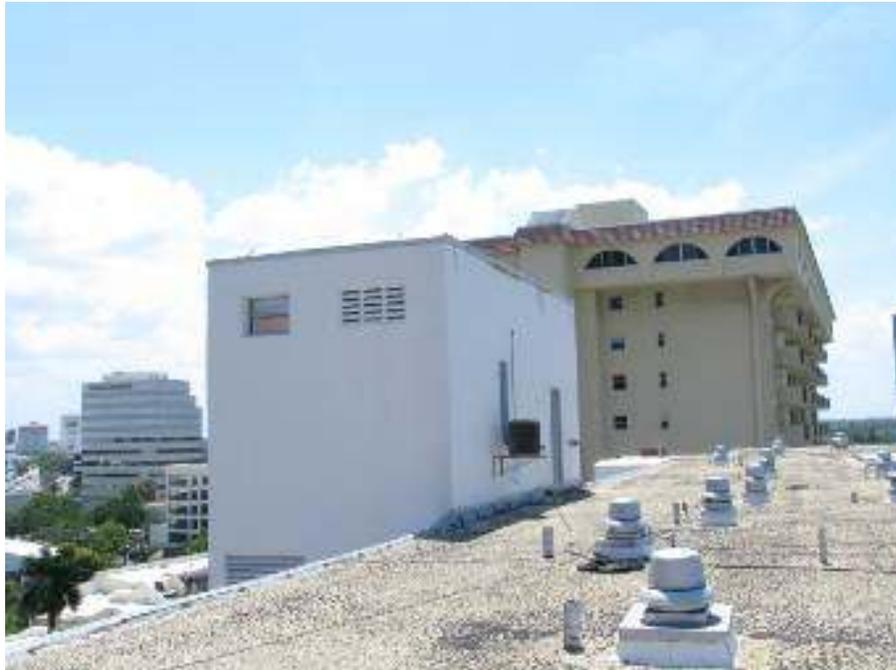
The roof is currently in OK condition, but will need maintenance / replacement within the next 5 years. The roof area is estimated to be about 7000 SF, so a total roof replacement will cost about \$85,000 and will last 20 years. Maintenance will need to be performed on a regular basis to repair leaks and other damage. KEG recommends continuing the inspection service provided by Crowther Roofing and making any recommended repairs.

Figure 2: Roof Site

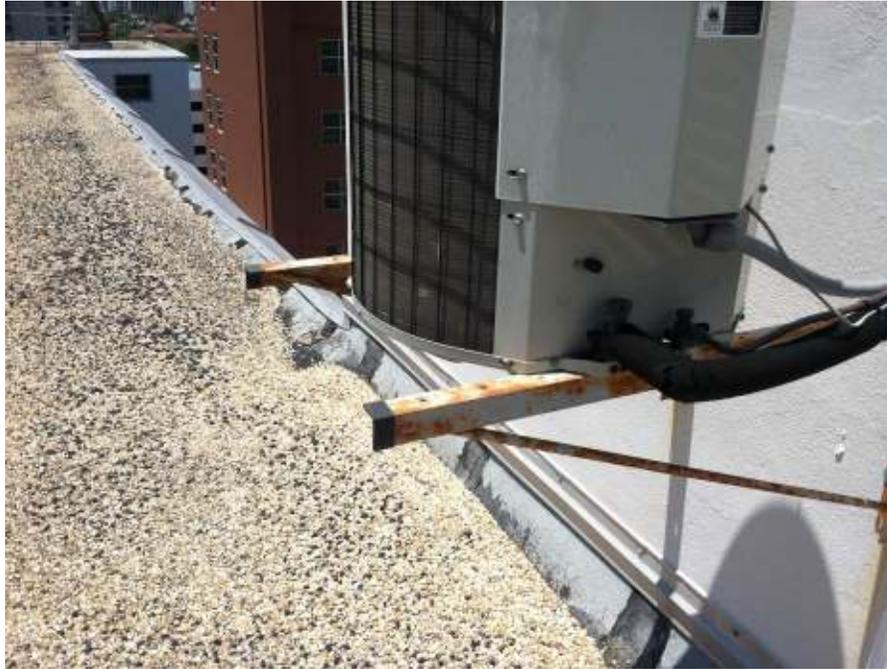
Figure 3: Corroded A/C Frame and Roof

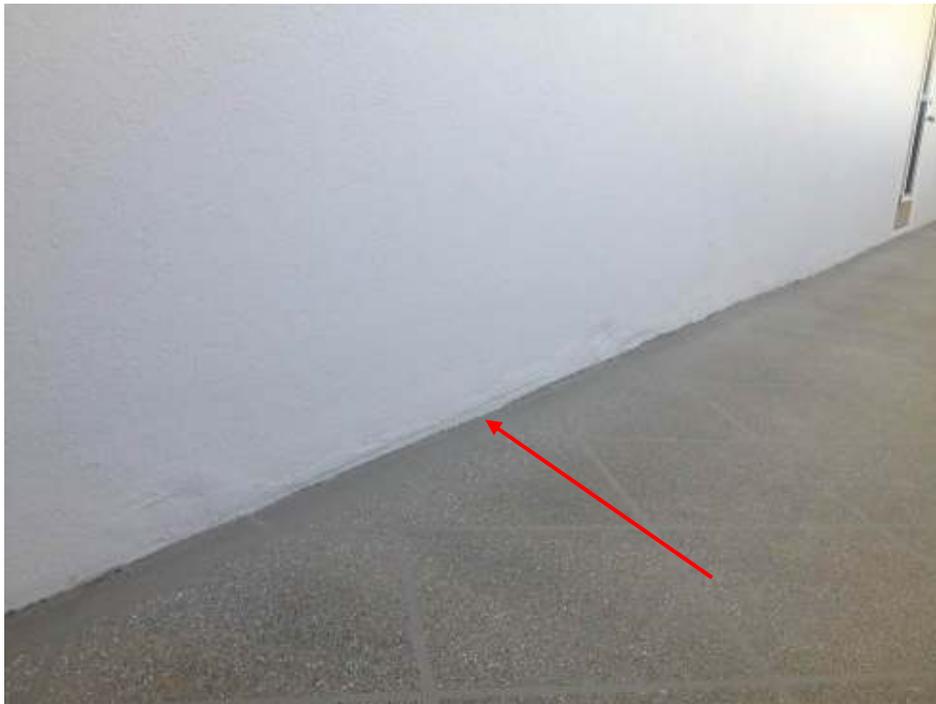
Concrete issues on the building were widespread, with issues affecting the walls, ceilings, and knee walls. It appears that the most recent stucco work did not honor the joints in many places, resulting in cracking and uneven finished texture. See figures 4-6. These cracks develop when there are no (or improperly installed) vertical control joints at dissimilar substrates, which will shift differently from one another based on the temperature, humidity, etc. For more, please see the attached paint and sealants conditions report.

Figure 4: Uneven Texture on Walkway Wall

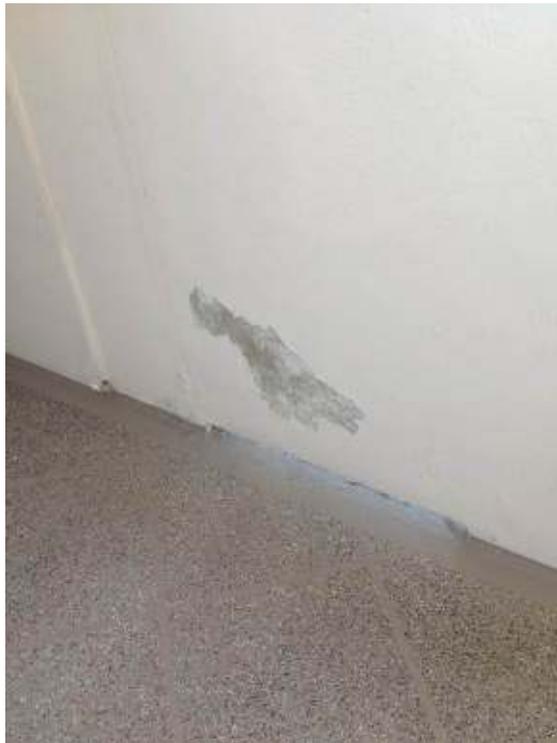
Figure 5: Improper Surface Preparation has led to Paint Peeling from Knee Wall

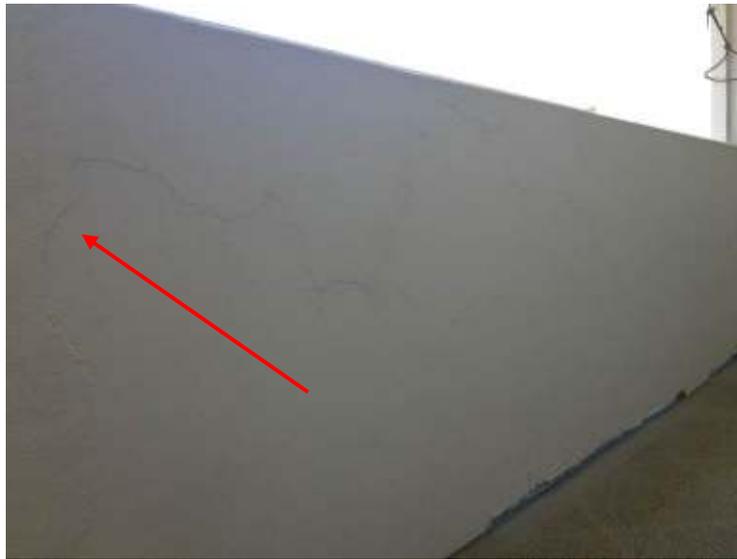
Figure 6: Improper Finishing on Walkway Knee Wall

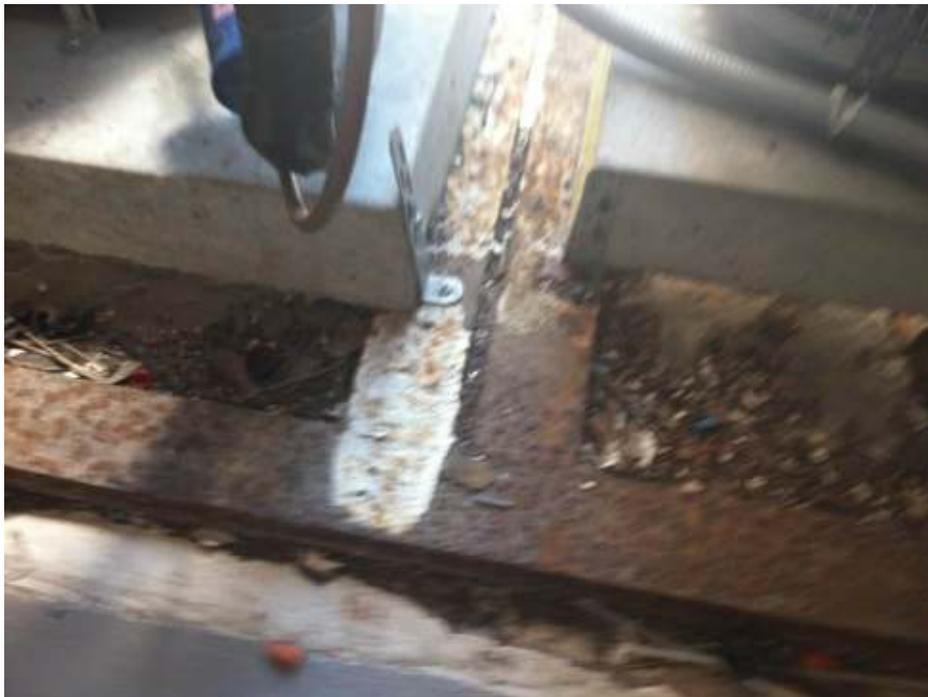
Although the air conditioning condenser units themselves appear to be in decent shape, the stands on which they sit at each end of the elevated walkways are in very bad condition. The cantilevered ferrous metal frames that hold the concrete hurricane pads are anchored to the walls poorly. In some cases the walls to which the frames are anchored are showing serious signs of deterioration and spalling. See figures 7 and 8. KEG recommends that steps be taken as soon as possible to correct these structural deficiencies, as these stands pose a risk to anyone or anything below them in the event that they fall. KEG recommends the A/C condensers be moved to the new carport roofs. The carports should be planned to be replaced within the next year at a budgeted replacement cost of \$41,500.00. Included in the budget is the reinforcement of the new carports so that A/C condensers can be installed on the carport roofing system. Relocation of the current A/C condensers to the carport roofs, including filling of the holes at the walkway levels left from removal, has a budgeted replacement cost of \$56,000.00.

Figure 7: Metal Frame Holding A/C Units Showing Severe Deterioration

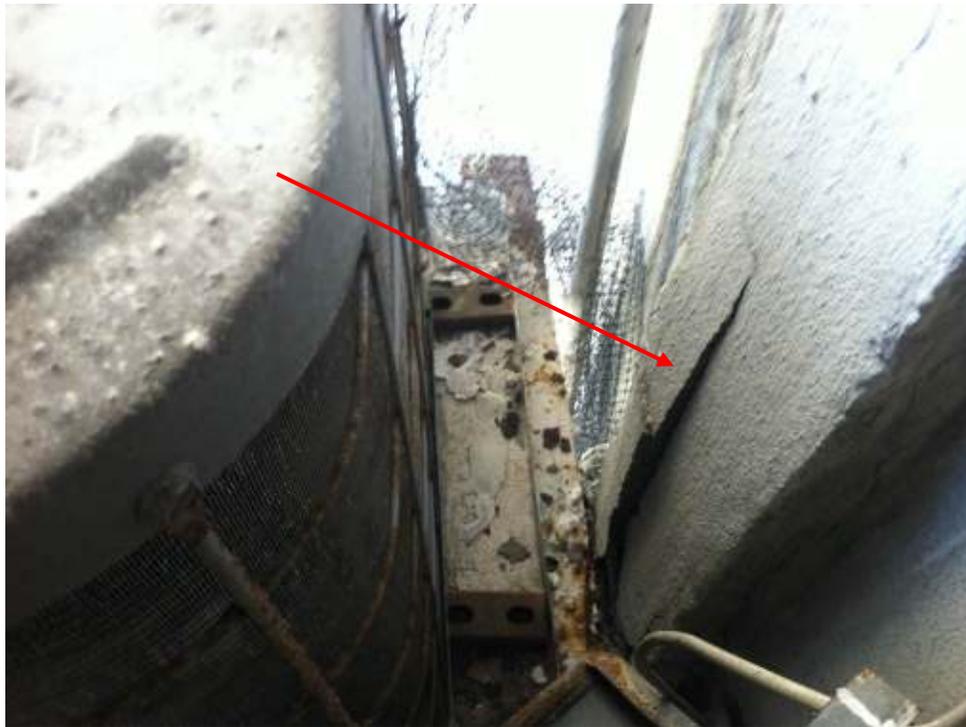
Figure 8: Severe Spalling on Wall where A/C Frame is Anchored

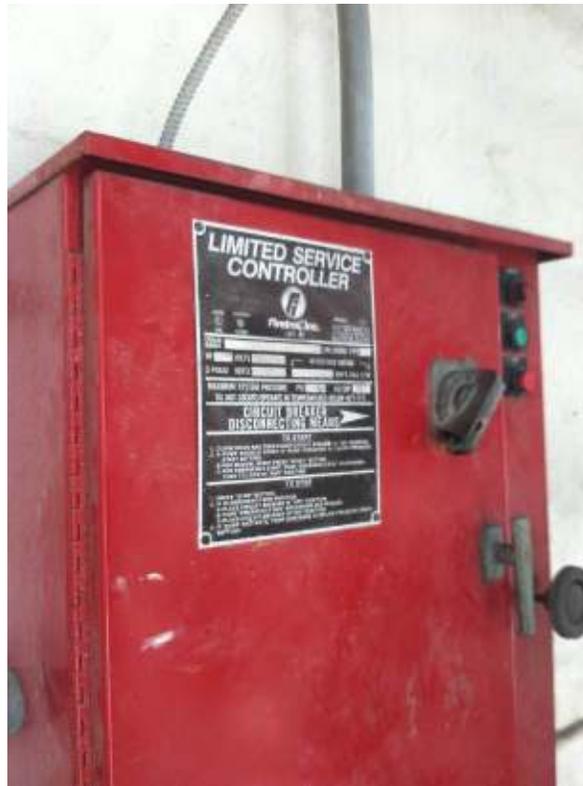
Figure 10: Fire Control Box

The “Silent Knight” fire alarm control panel appears have been installed in 2006 and regularly inspected. Panel replacement cost is budgeted at \$23,800 at 25 year intervals.

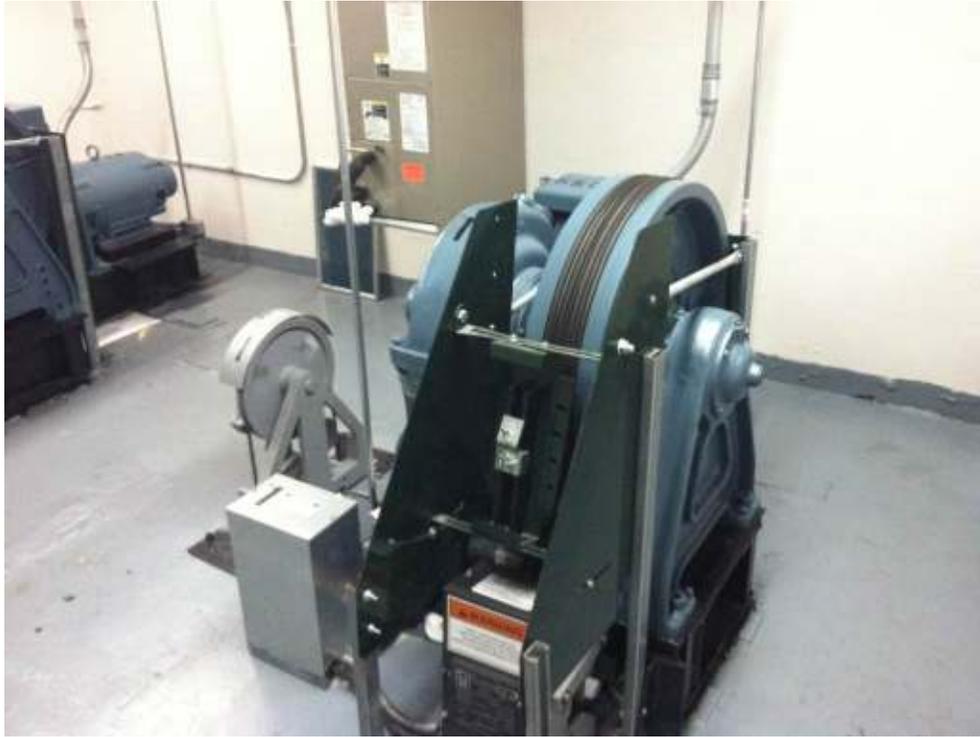
The refurbishment of elevators should take place at approximately 30 years which is the expected useful life for these two elevators. The future refurbishing/replacements are budgeted at \$55,000 each or \$110,000 total at each 30 year interval.

Figure 11: Elevator Equipment in Good Condition

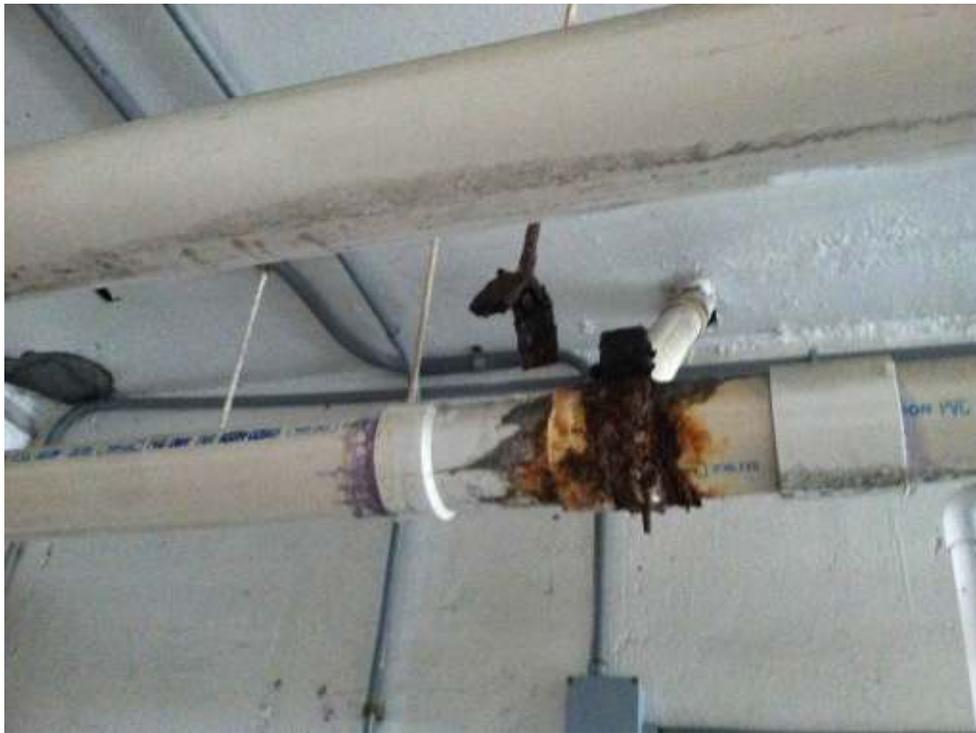
The plumbing system appears to be nearing the end of its useful life, given the location of the building, cast iron piping installed and recent history of leaks the association may wish to include budgeting for service repairs and replacements with the useful life to near its end in 2017. The anticipated plumbing system replacement cost is budgeted at \$265,000. In the interim, replacement of isolated waste stacks and isolated leak repairs are likely to occur. KEG also observed some of the cast iron piping in the garage area is in advanced corrosion and may need to be replaced within the next 2-3 years.

Figure 12: Plumbing showing signs of Deterioration

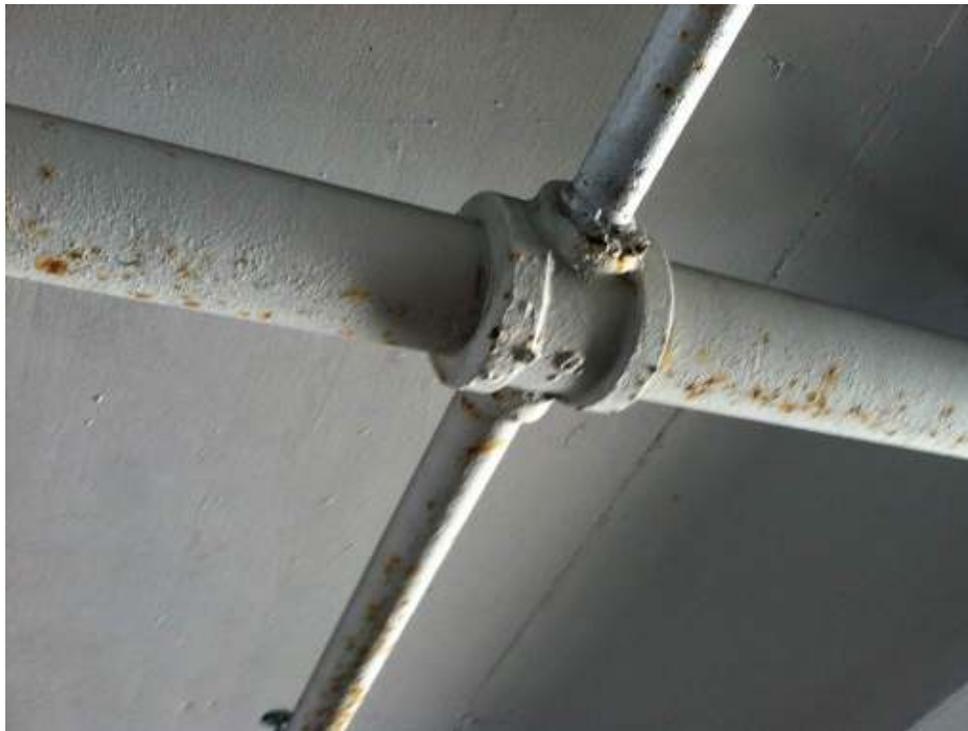
Figure 13: Oxidation showing on Plumbing

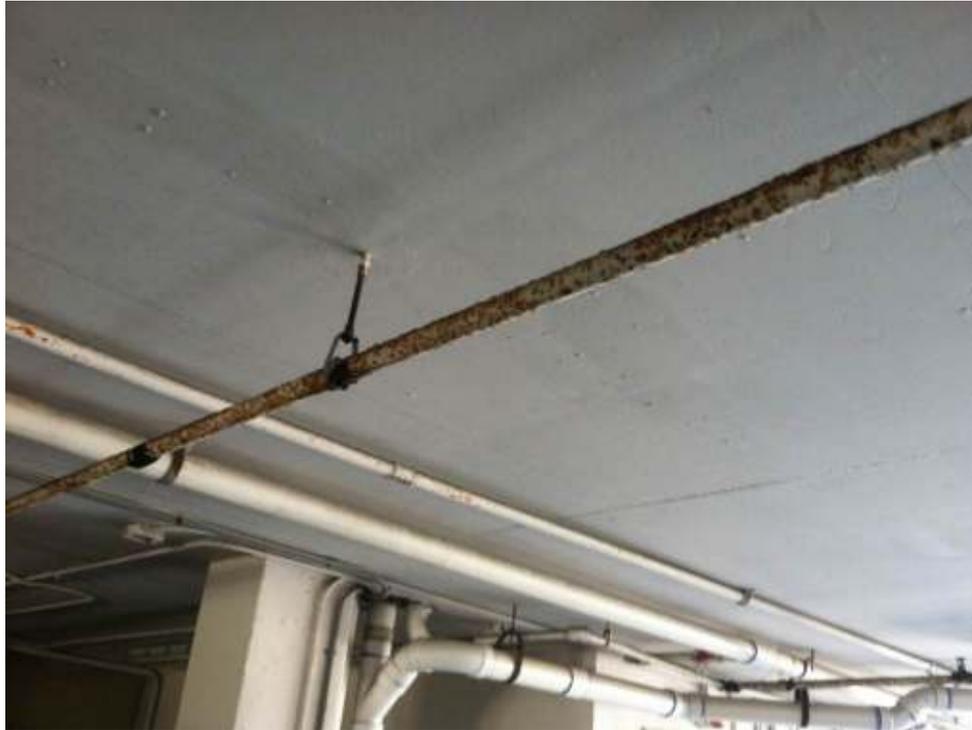
Figure 14: Corroded Pipes in Garage

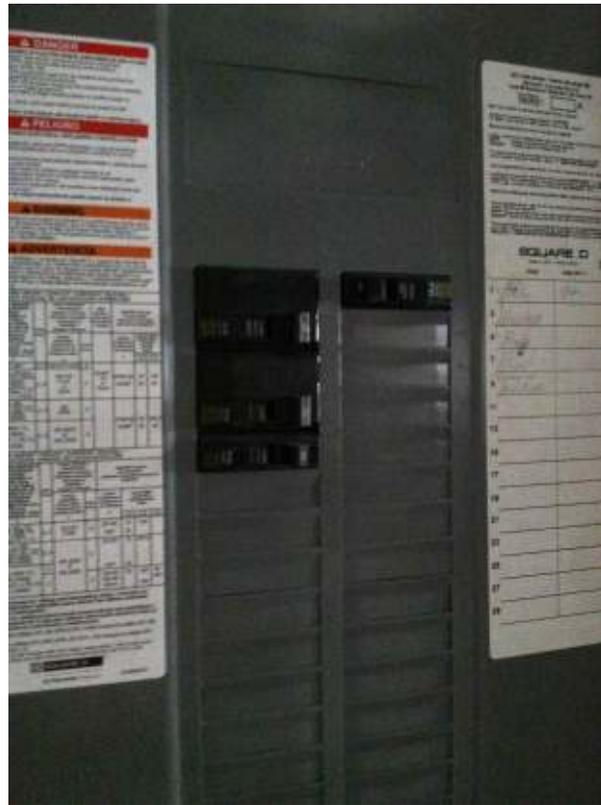
Figure 15: Breaker Box in Good Condition

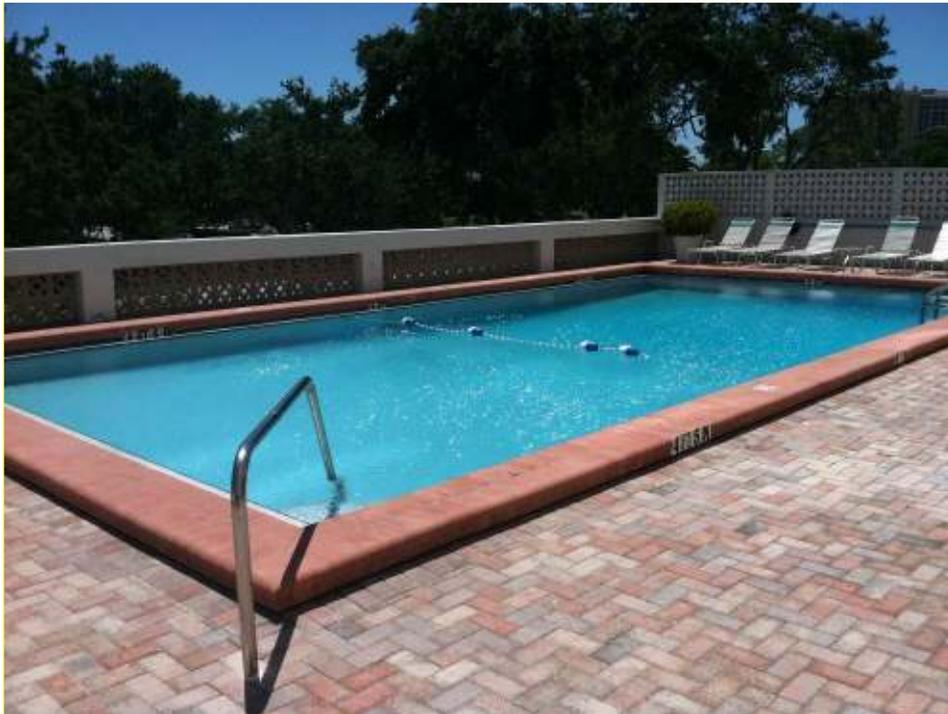
Deck- appears to be in good condition and refurbished in approximately 2003. The anticipated budget for replacement at 40 years is \$45,000. There are a few areas where leaks have been reported in the parking garage below the pool deck.

Figure 16: Pool and Pool Deck Pavers in Good Condition

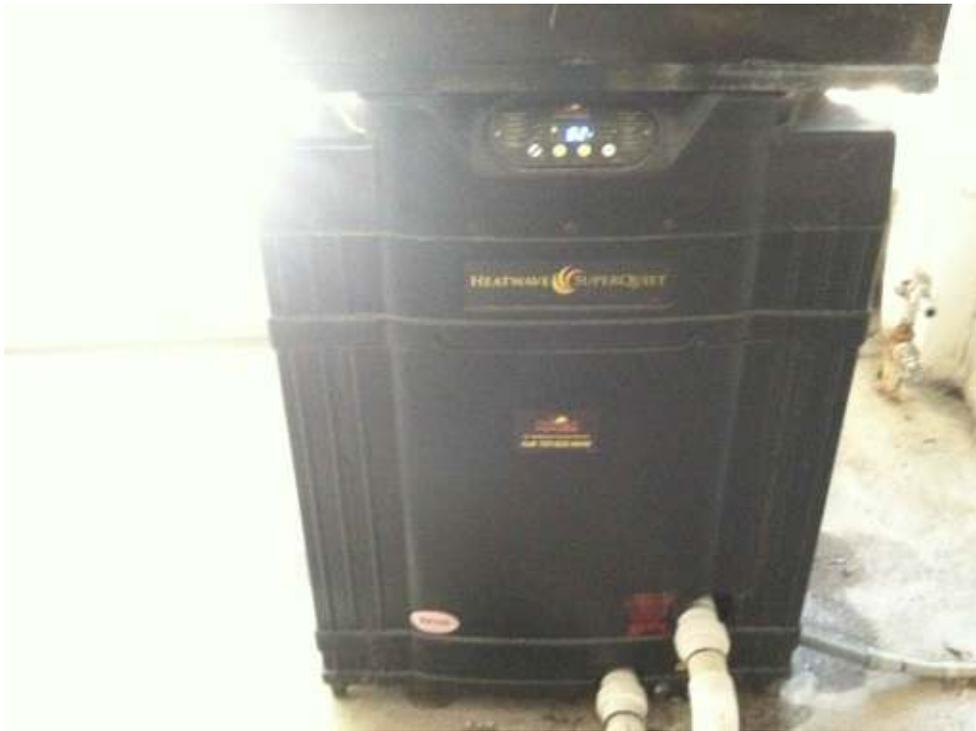
Heater- the “Heatwave” heater was installed in 2011 and appears to be in good condition. The anticipated budget for replacement at each 10 years is \$5,400.

Figure 17: Pool Heater in Good Condition

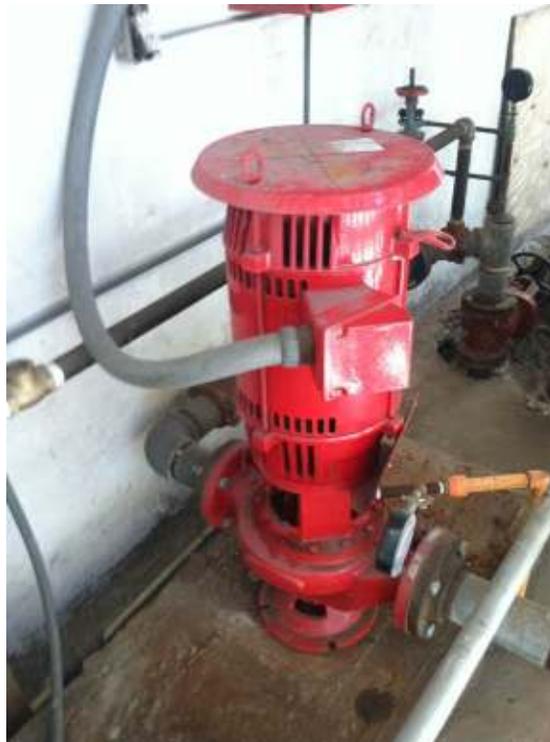
Figure 18: Pool Pump

Equipment- the “Marathon” pump, “Hayward” filters and related equipment appear to be in average condition with the most recent replacement installation in 2008. The anticipated budget for replacement at 10 years is \$500.

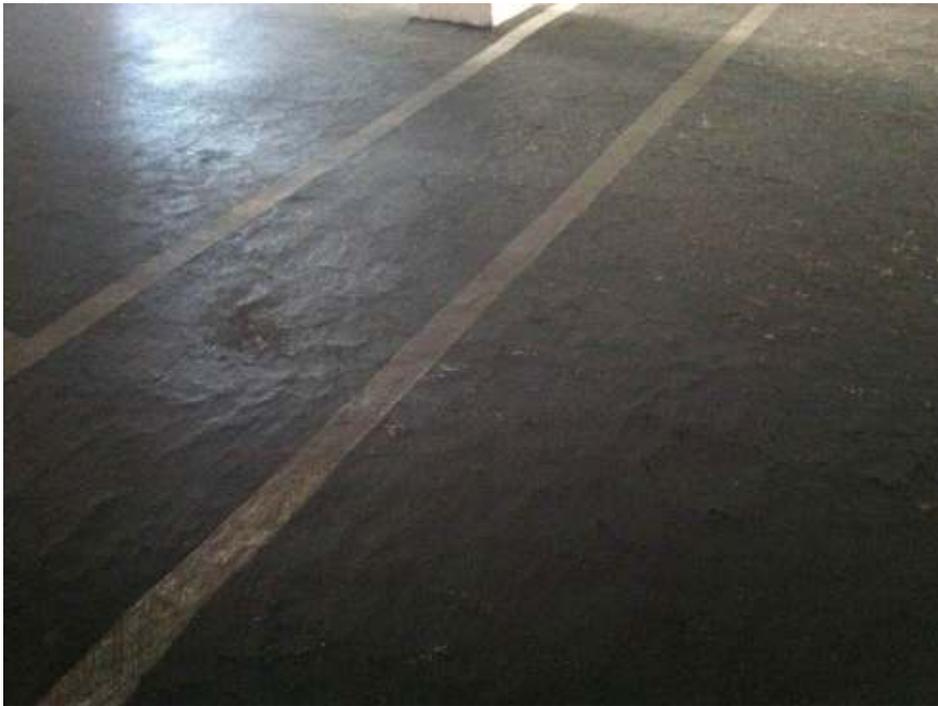
The asphalt was reportedly last sealed in 2006. The normal maintenance requires the asphalt to be sealed every five years. Given the condition of the current asphalt, it is beyond sealing. When the asphalt becomes too deteriorated to seal, the maintenance required will be to install a 1-1/2" overlay. The budget amount for the overlay is \$10,000 at each 15 year interval and should be completed in the next 2 years. See figures 19 and 20.

Figure 19: Pavement showing Normal Sign of Deterioration

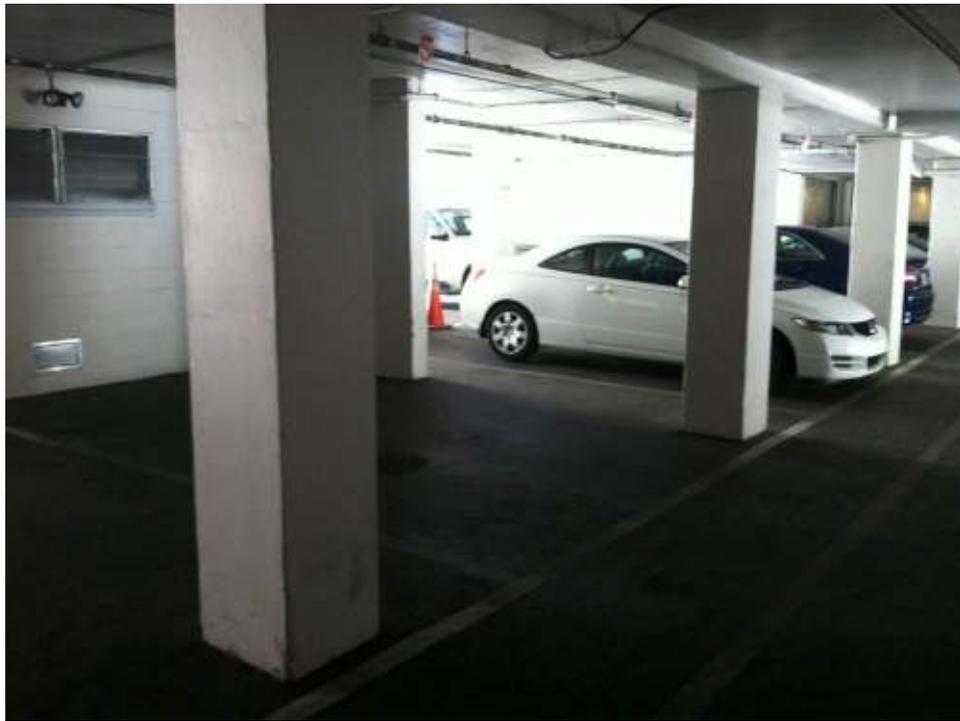
Figure 20: Garage Structural Members in Good Condition

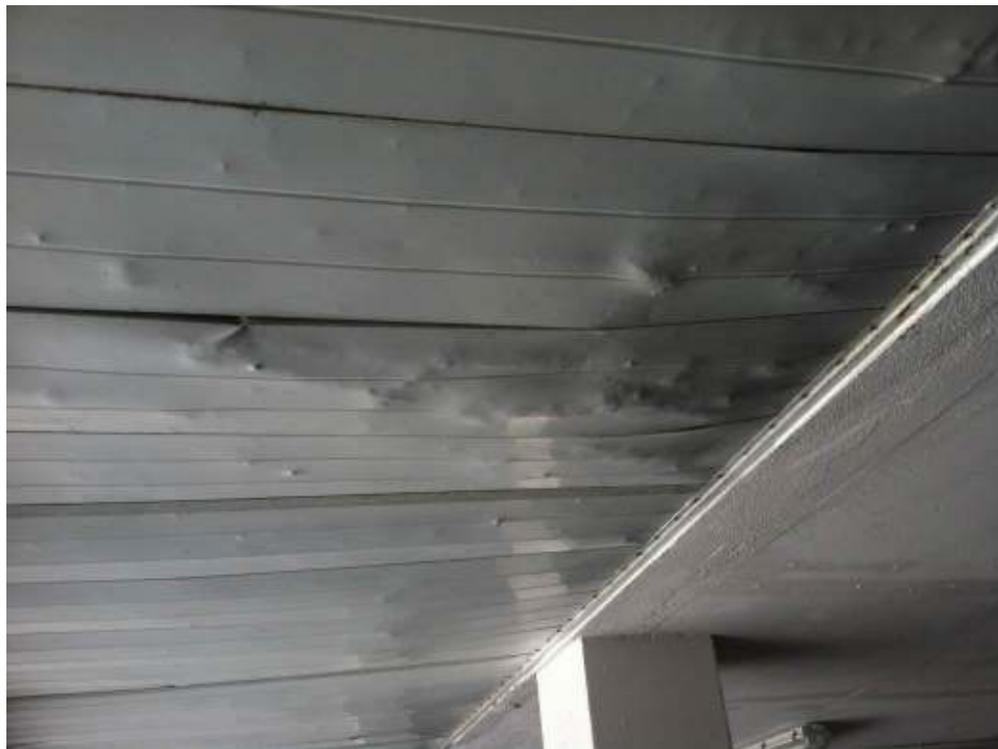
KEG also notes that the small carports on both ends of the parking garage are in poor condition. See figures 21 and 22. Carport replacement is budgeted at \$41,500 and should be scheduled as soon as possible. The aforementioned budget number includes the installation of a reinforced carport system that can support the installation of A/C condensing units once they are removed from their cantilevered frames.

Figure 21: Damage to Carport Roof

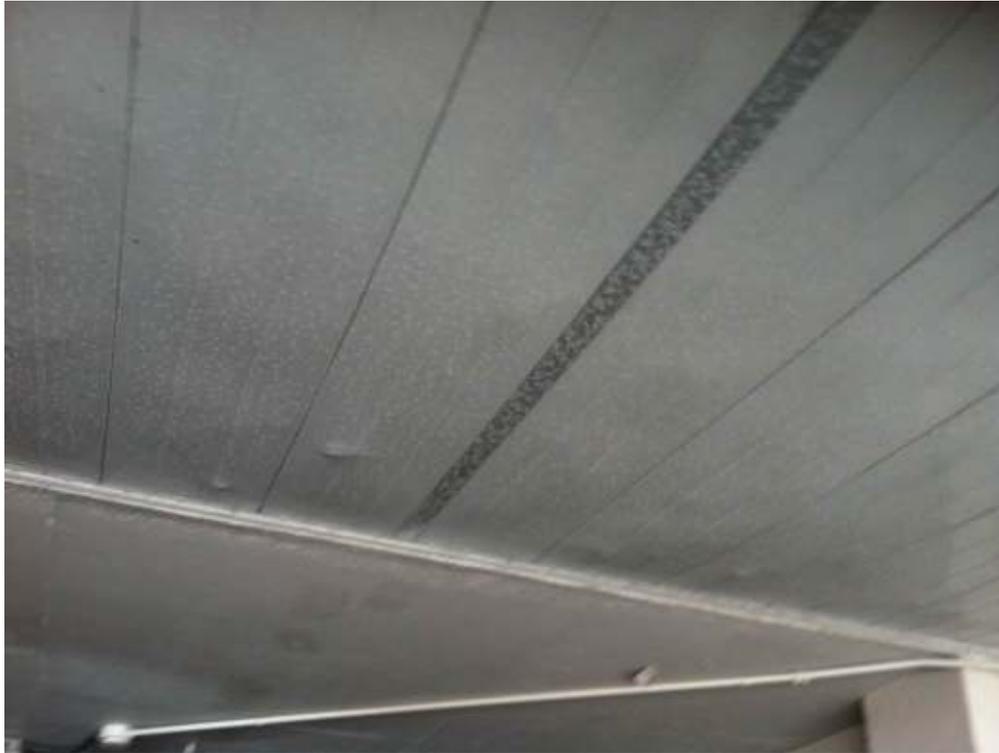
Figure 22: Carport Roof showing Signs of Oxidation
